CONDITIONING DELHI METRO PHASE-III

**Chris Cooper, Project Leader, CEC-CICI Jv,
G.Jagadeswara Rao, Sr.Manager-Survey
(TBM), CEC-CICI Jv, and Lars Langmaack,
Technical Manager TBM, Normet International
Ltd, explore the Soft Ground Tunnelling
challenges faced on the Delhi Metro Phase III -
CC04 and how the selection of the right soil
conditioner and the ratio of mixing were the
key factors for success.**

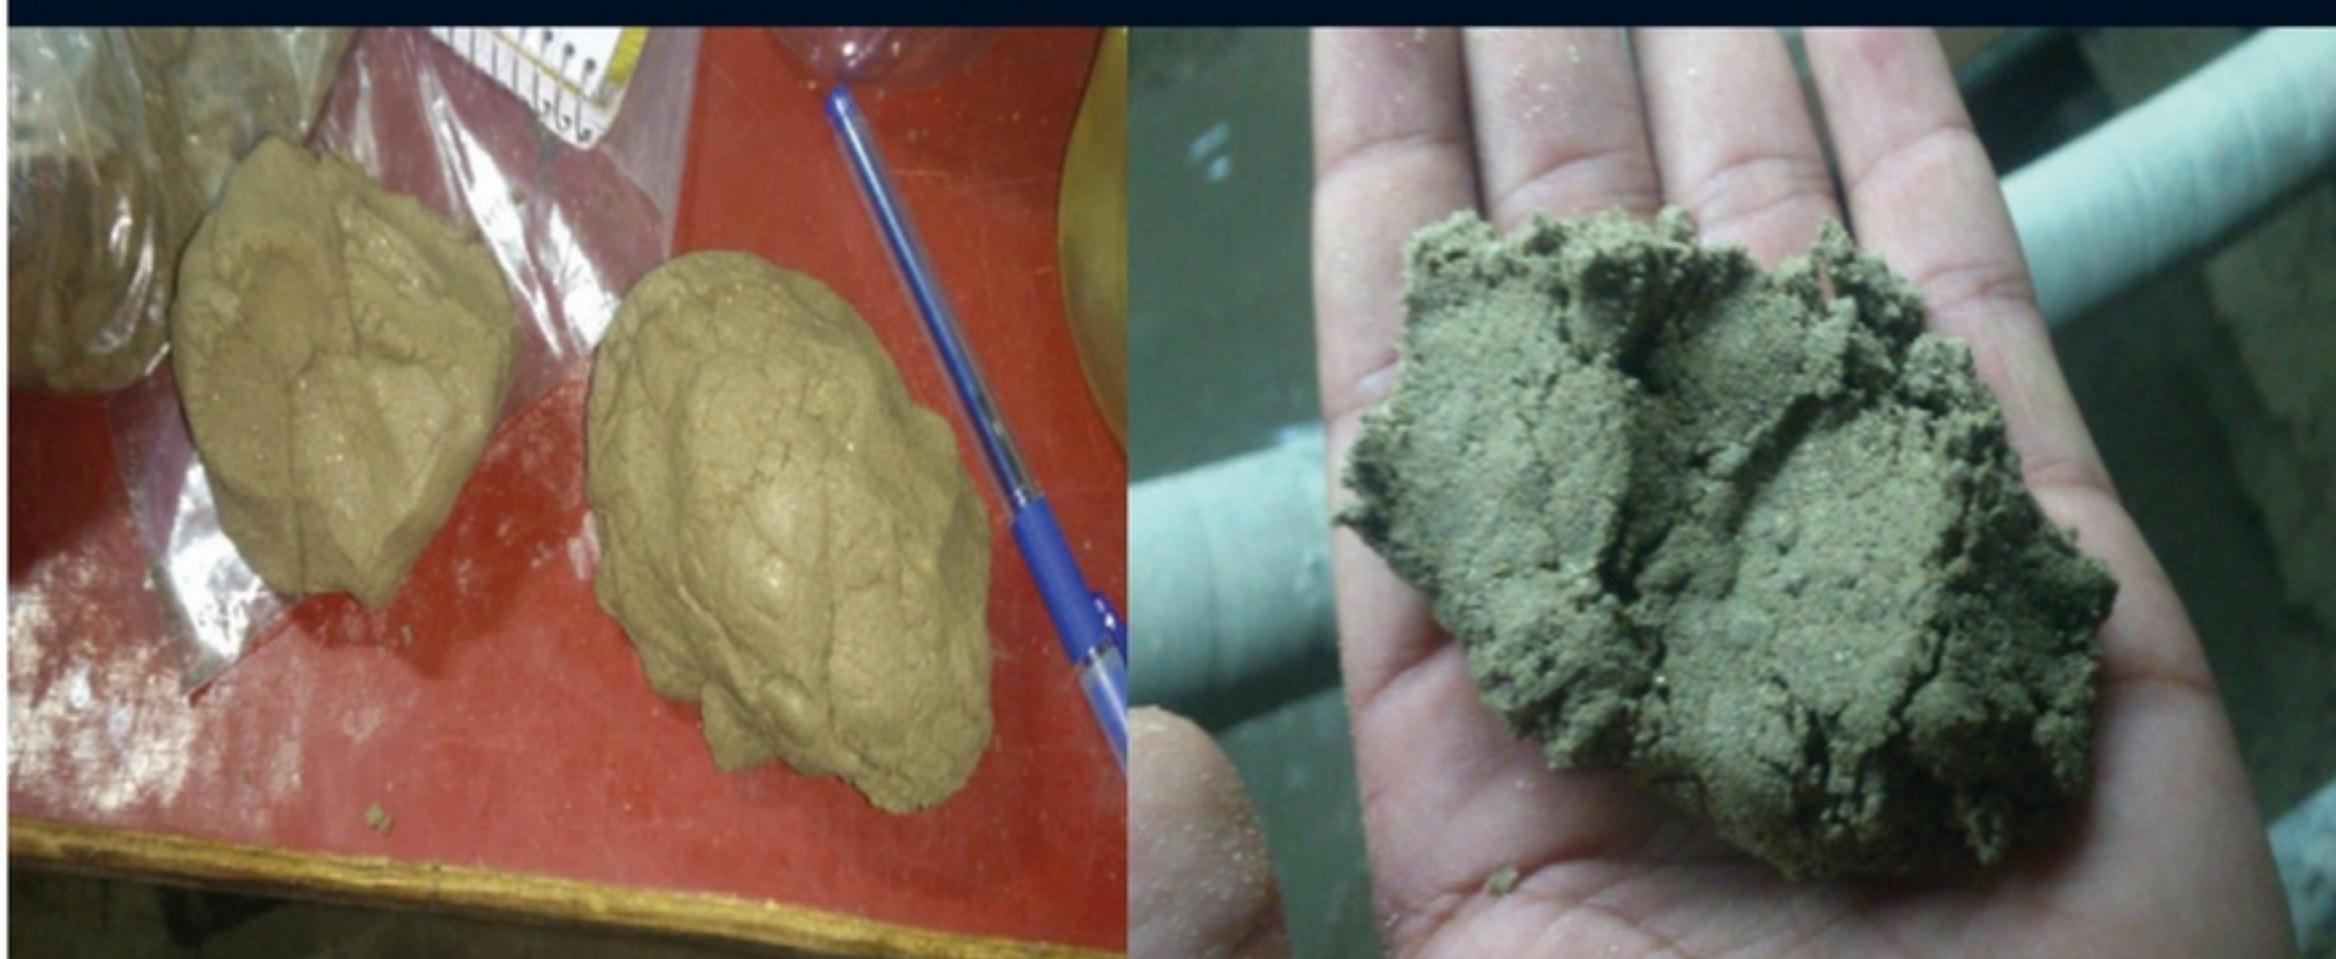
Figure 10a and 10b: The result show drastically improved cohesion

Figures 10a and 10b are pictures showing the Tunnel Muck after applying TamSoil 600CP.

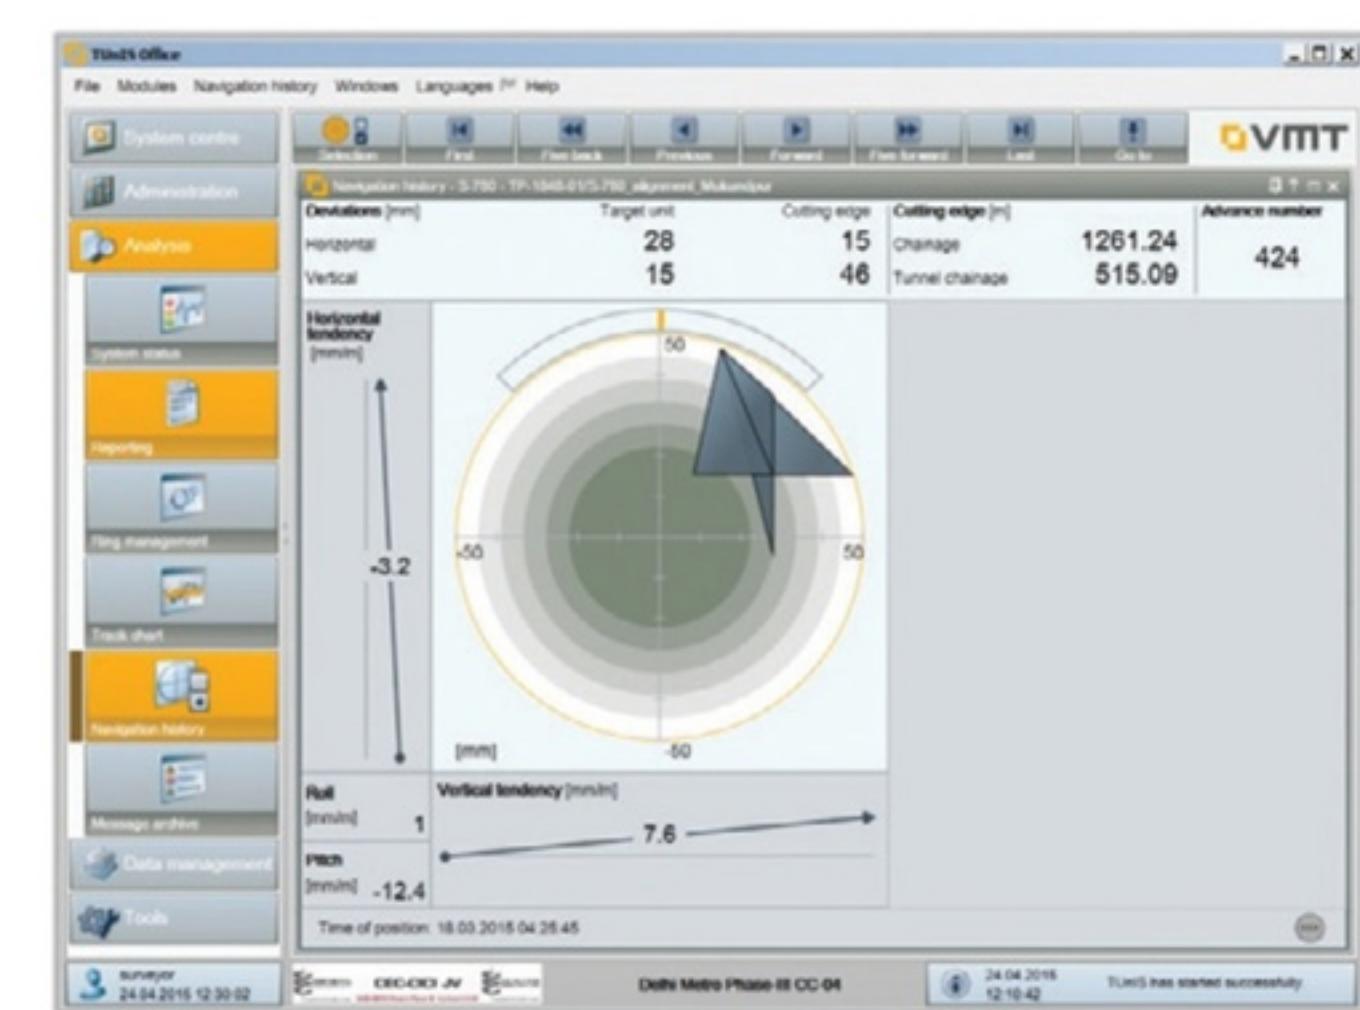
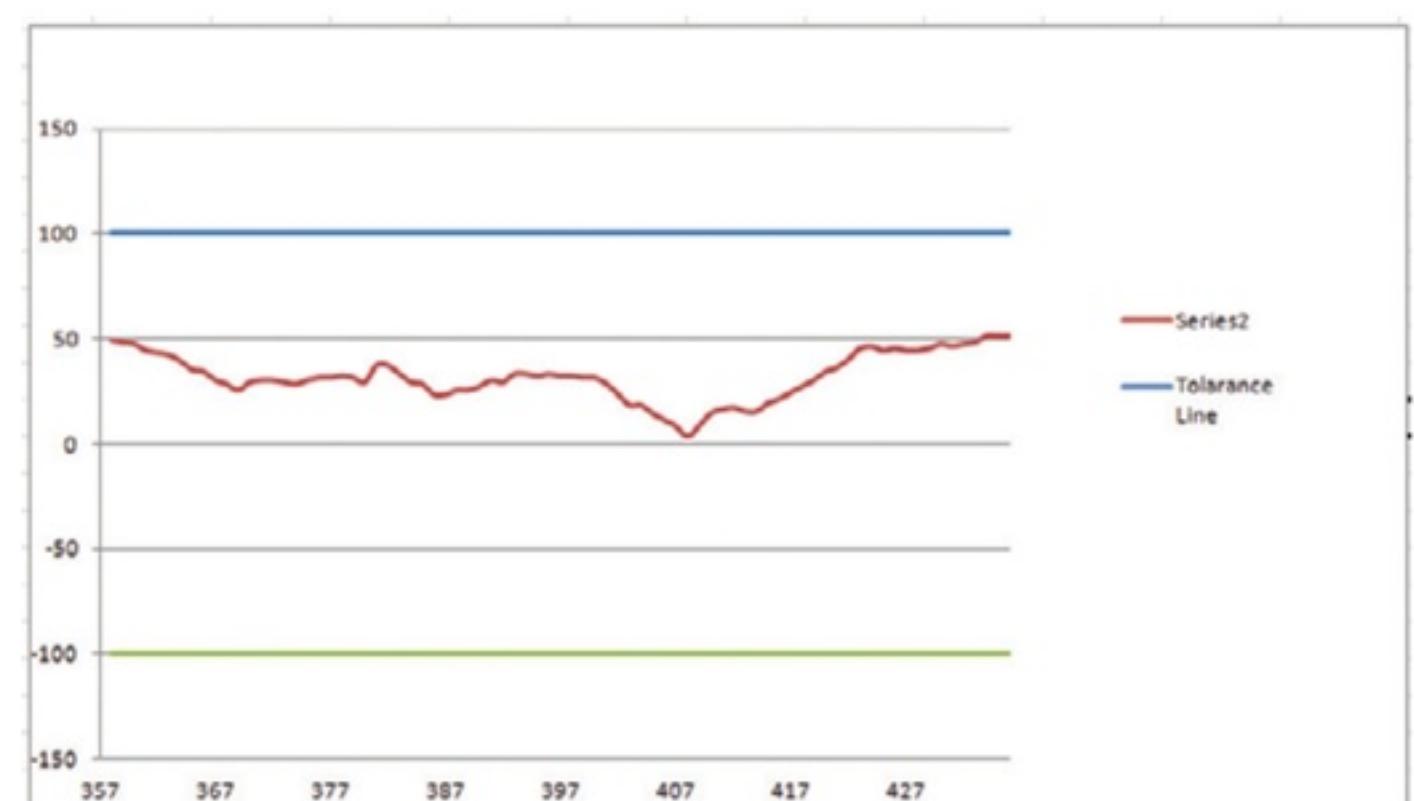
Figures 13a and 13b – Back on track at Ring No.424

In the end, the machine was brought back on track at advance no.424 with a position of 40mm above axis and all thrust cylinders once again used for the mining process.
