Frankfurt U5 metro extension – the challenging high pressure inner city project

T. Schade & R. Iffländer

ABSTRACT: Frankfurt, one of the most densely populated capitals in Germany, needed an extension of its Metro Line U5 from the main railway station towards the newly created district ‘Europaviertel’ which is part of an urban rehabilitation plan affecting over 30.000 people.

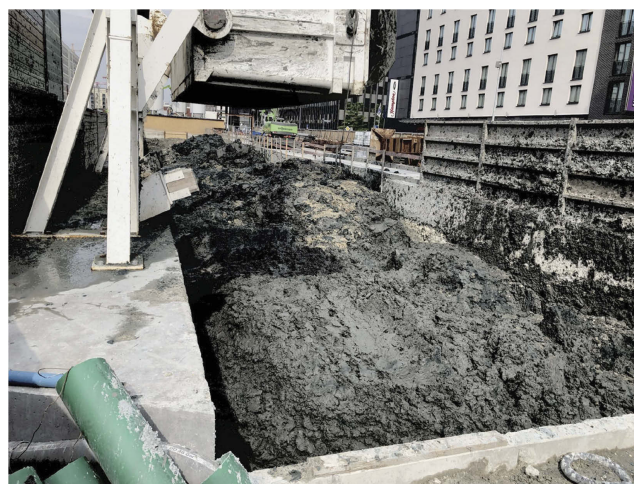
Figure 9. Conditioned Frankfurt Clay at station surface, June 2020.

The soil could be easily excavated and transported by muck cars, the muck car emptying process was without any difficulties. The further manipulation with excavators and truck loading, truck transport and transfer to barge carriers was smooth and without any problems (see Figure 9).

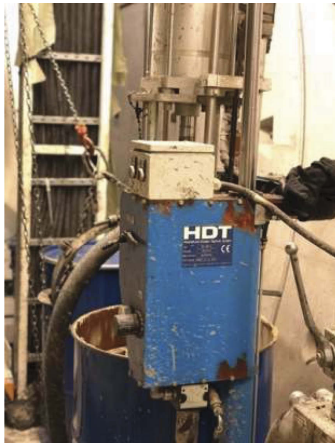
Figure 16. HDT 200 T press plate pump for tail sealants.

The U5 extension project used the highly ecologic MC-Montan Seal ST11 tail sealant, based on renewable oils and exempt of plastic fibres to protect the environment as best as possible. Furthermore, HDT 200 T press plate pumps were plug and play installed on the gantry to ensure an almost revision free pumping. For the whole project, the sealing sets had to be replaced only once for the total of the 2 drives.
